Manhole Inspection Summary

Manhole # S51C__008MH

Location Address: **37 n decker ave** Cross Street: **e fairmount ave**

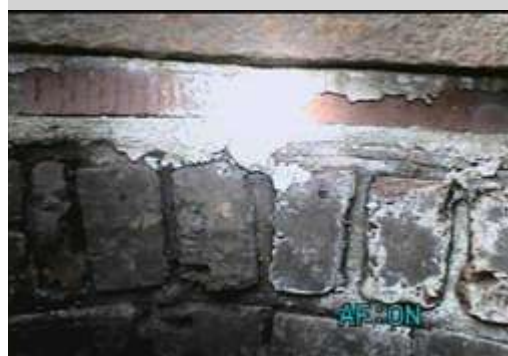
Defect 2

bench debris

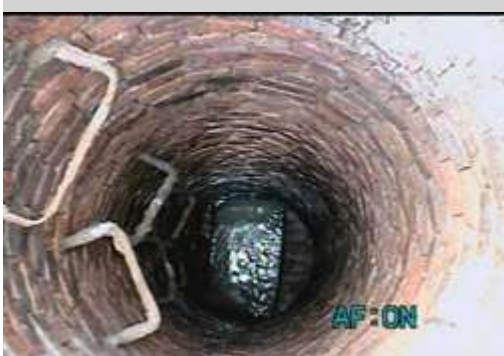
Defect 1

Condition: ☐ Sound ☐ Cracked ☐ Root Intrusion ☐ Loose Brick ☒ **Deteriorated**

frame adjustment deteriorated

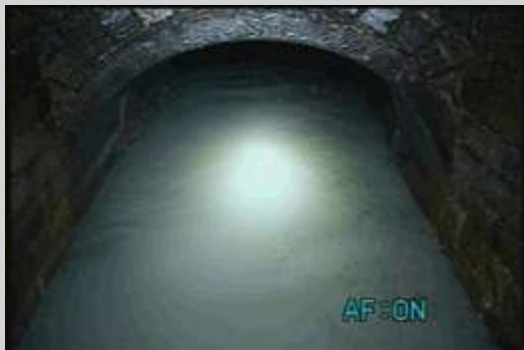
12 O'Clock Outflow

27 in. Circular Gravity Sewer
Pipe Out @ 12 O'Clock

Pipe Material: **Clay** ☐ Pipe Lined

Invert Depth: **19.82** (ft.) Flow Characteristics: **Fast**

Infiltration: **None** Pipe Seal Cond: **Unknown**

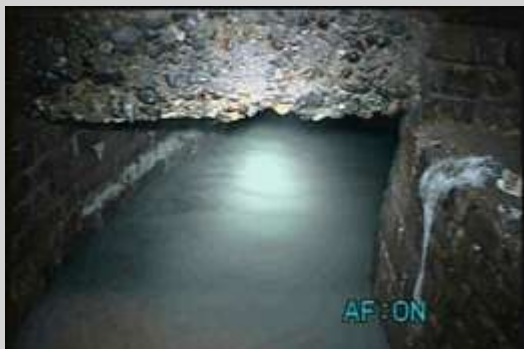
6 O'Clock Inflow

27 in. Circular Gravity Sewer
Pipe In @ 6 O'Clock

Pipe Material: **Clay** ☐ Pipe Lined

Invert Depth: **19.76** (ft.) Flow Characteristics: **Fast**

Infiltration: **None** Pipe Seal Cond: **Unknown**
